Guide to Damp and Condensation

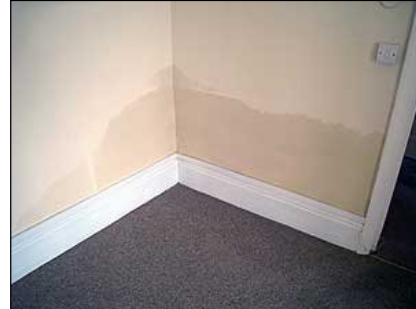
Damp patches appear lower down on the wall. Rising damp is where dampness is coming up the wall from the ground because the damp proof course is not working.

The most obvious sign of rising damp are a brown "tidemark" on the wall and the plaster below feels cold or damp to the touch. Rising damp can affect any wall in contact with the ground and therefore can affect internal and external wall structure.
